**WASTEWATER  
HANDRAIL POSTS  
CONCRETE REPAIR**

CONCRETE REPAIR  
JUNE, 2015

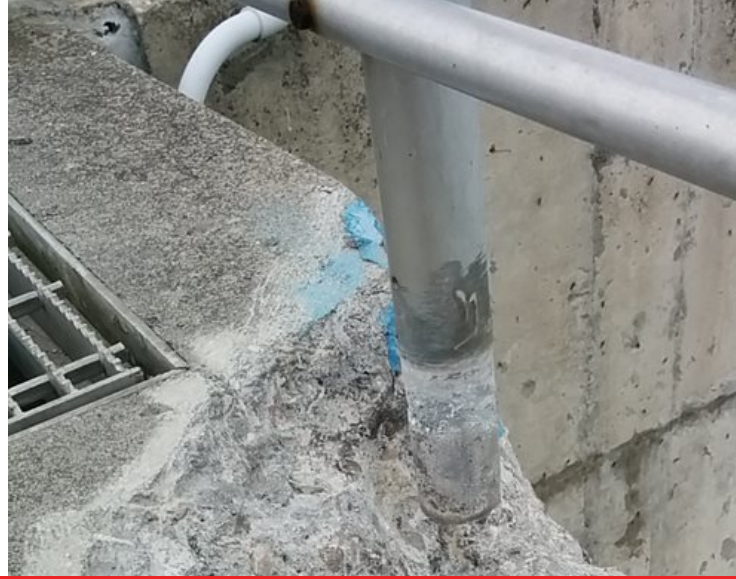
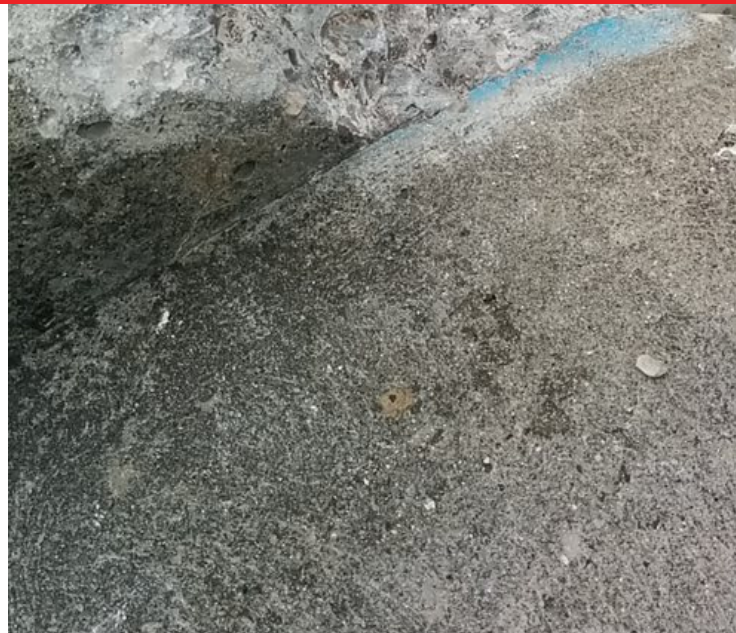
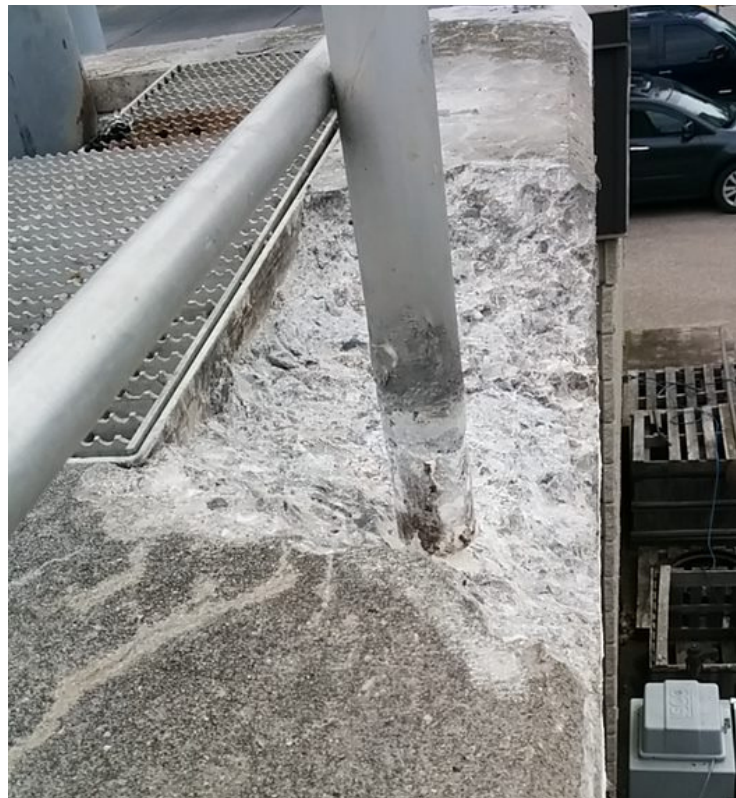
A wastewater treatment plant in the city of Straffordville was having issues with the concrete around several of their handrail posts. Some of the damage was from a combination of environmental (freeze thaw effect) and proximity of the concrete to the clarifier tanks.

Concrete has a reputation for being extremely durable and long lasting, but many facility managers are unaware that concrete is also highly susceptible to long-term damage from chemical attacks. The porous nature of concrete allows for chemicals to easily permeate through concrete.

We visited the site and after inspection we recommend Belzona 4131 (Magma-Screed) for this application.

Before product application, a grinder was used to prepare the surface and any loose concrete was removed. Belzona 4911 (Magma TX Conditioner) was applied to the prepared surface using a stiff bristle brush. Then, Belzona 4131 (Magma-Screed) was applied in accordance with Belzona Instructions For Use.

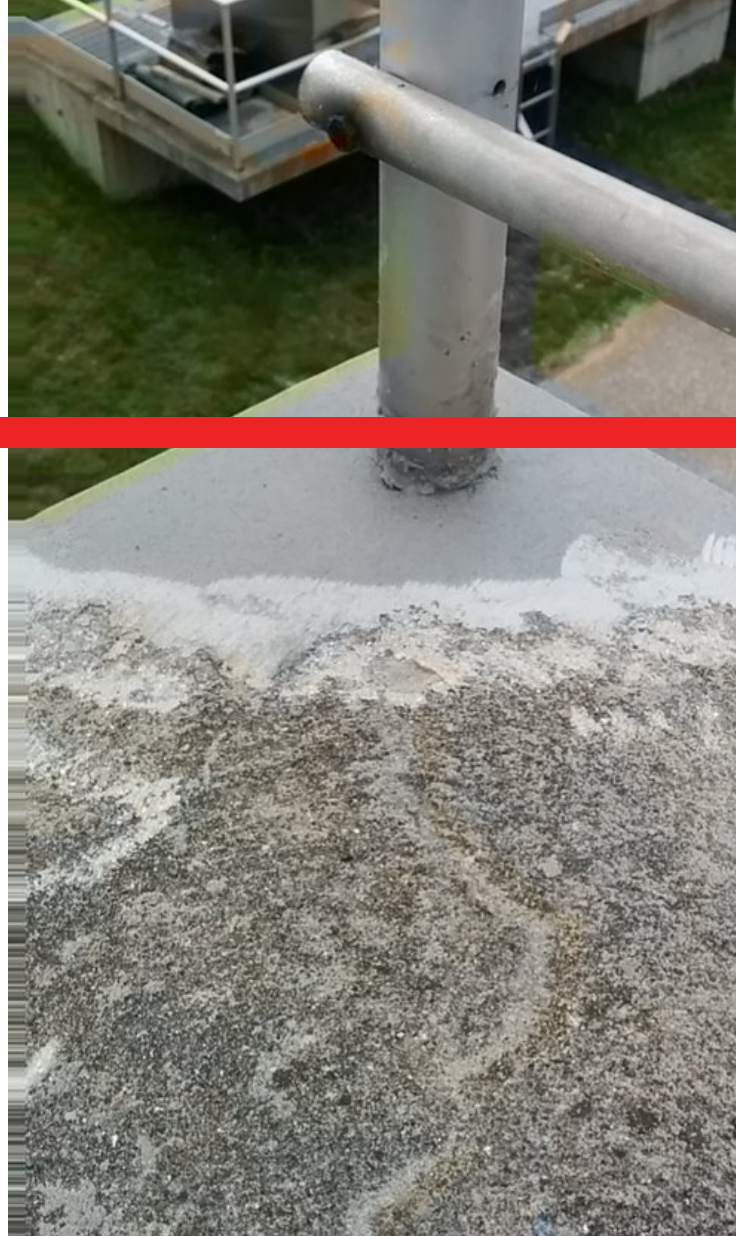
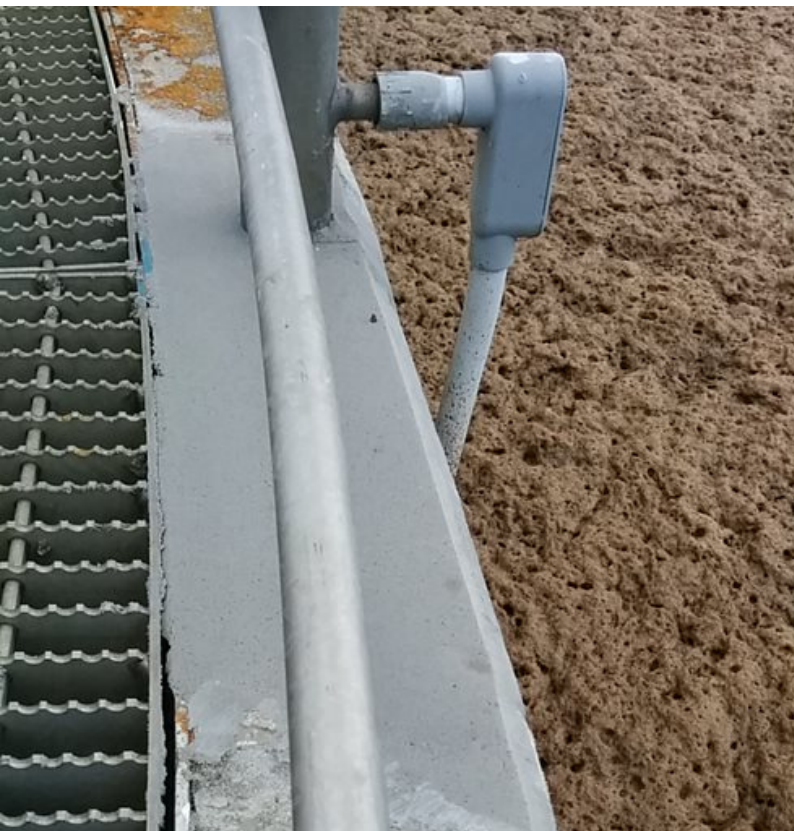
A wooden mold with Belzona 9411 (Release Agent) was used to achieve the correct dimensions. Then, a trowel was used to achieve a smooth finish.
